Benicia Refinery • Valero Refining Company - California

30 Day Report

March 25, 2024 Tank 1738 Oil on Roof
Report Completion Date: March 25, 2024

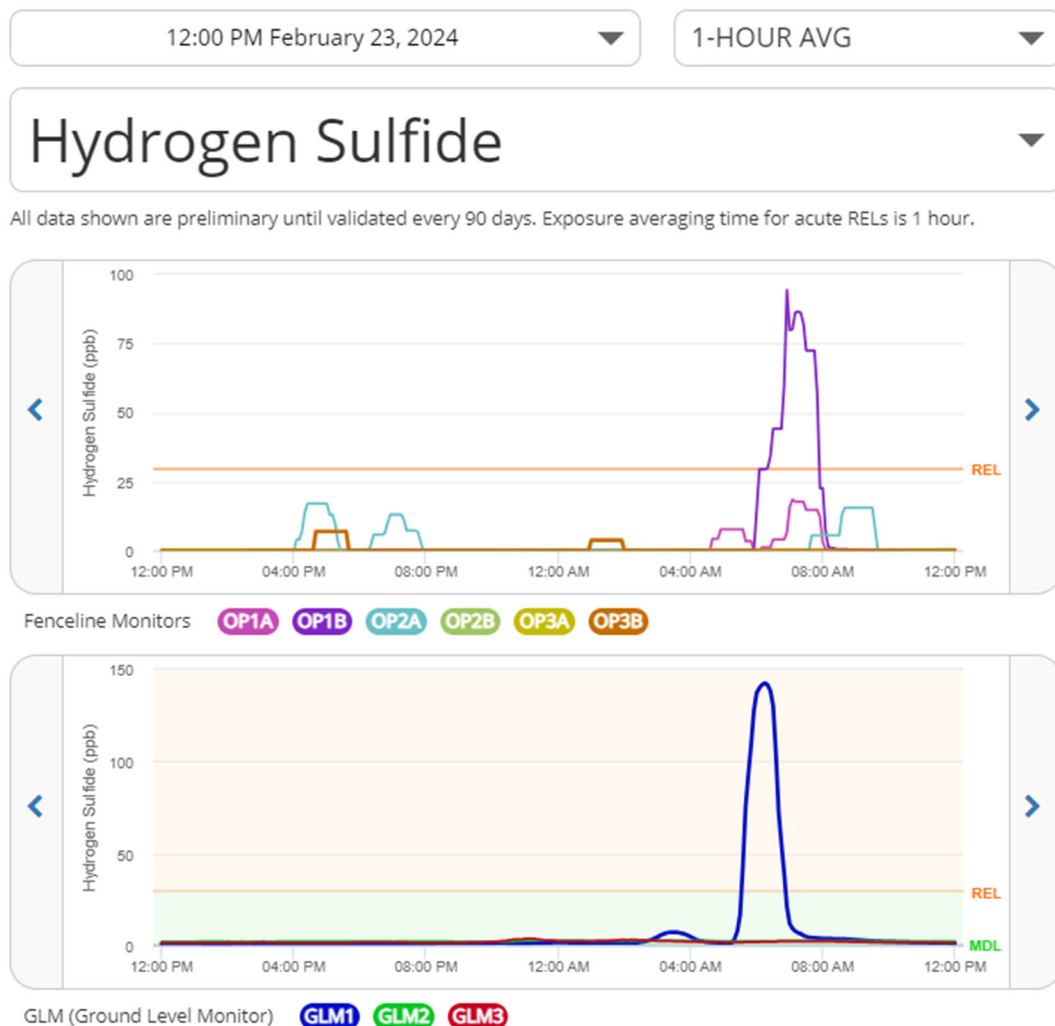
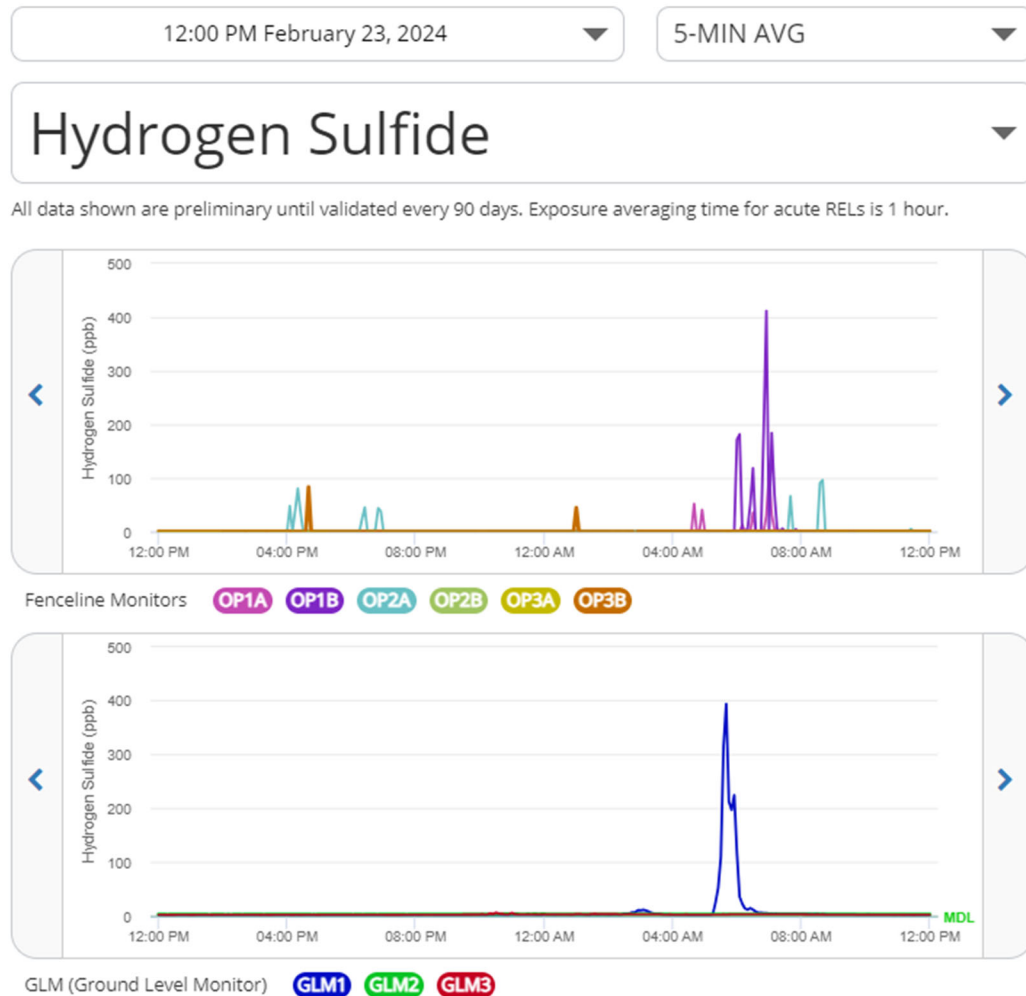
Figures 1 and 2: Open-Path Fenceline and GLM data 1-hr and 5-min average

At approximately 5:30am on Saturday February 24, 2024, the Benicia Refinery Fenceline monitors detected Hydrogen Sulfide (H₂S) above background levels Southwest of the Refinery (at GLM 1, OP1A, OP1B, and OP2A) that was accompanied by the signature odor of H₂S (rotten egg smell). The fenceline website data is available at www.beniciarefineryairmonitors.org. However, the Benicia Refinery Fenceline system did not detect a peak above the notification level of 30 ppb until 5:35am on GLM 1 and 6:25am on Path OP1B, as shown in Figures 1 and 2. Operations initiated follow-up validation monitoring at GLM 1 at approximately 05:45am.

Monitoring Location	Concentration Range of H2S
GLM 1	0.2 – 392.6 ppb
OP1A	0 – 109.8 ppb
OP1B	0 – 411.6 ppb
OP2A	0 – 96 ppb

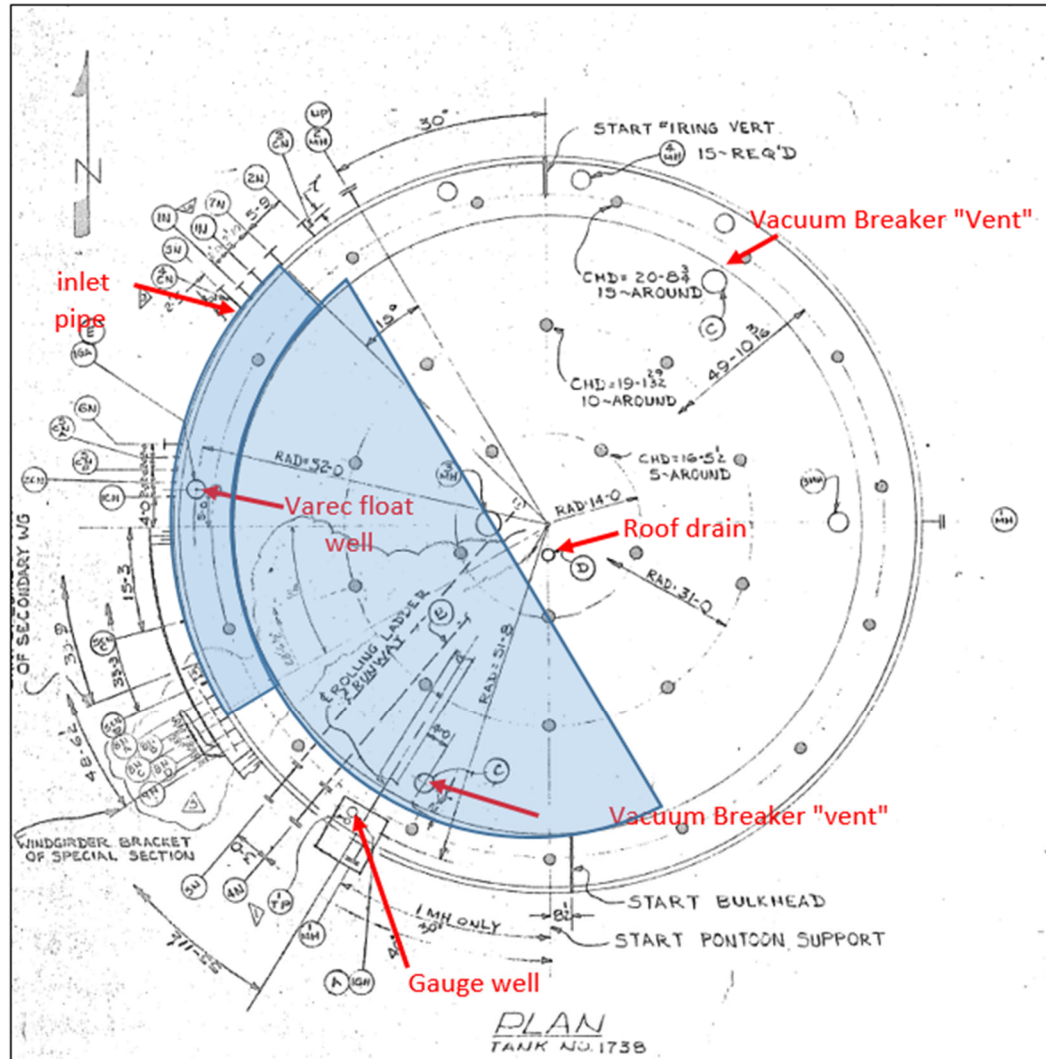
Figure 3: Markup of Tank 1738

The release point was determined to be a vacuum breaker vent, which is essentially a pipe with a cap that is air-tight under normal conditions but has the ability to lift to atmosphere under pressure, which would have occurred if vapors entered the tank. There was also evidence of liquid hydrocarbon near one of the two vacuum breakers indicating a point of release. The tank seals were eliminated as a possible source because there were no significant gaps or damage to the seals identified in the seal inspection immediately following the event and there was no evidence of liquid hydrocarbon at that potential release point.

The release estimate volume and duration were determined based on the tank level instrument data combined with an as-found inspection. Based on the available information, the investigation team estimated that the vapor release was approximately 3,297 lbs. of hydrocarbon, including 0.6 lbs. of Benzene and 4 lbs. of H₂S.

The investigation identified that the floating roof on Tank 1738 had slightly tilted, and was most likely caused by vapors entering the tank. The investigation team looked at the various sources of slop material that were routed to the tank during the event to identify potential sources of lighter hydrocarbon materials to the tank. From those potential source streams, there was insufficient data for the team to identify which stream was the conclusive source of the vapors.

Root/Supporting Cause	Corrective Action	Completion Date
Light hydrocarbon materials vaporized in Tank 1738 vaporized causing roof tilt and atmospheric release.	Develop engineering solution for the potential slop sources and options for monitoring/alarms, procedural options, or other means to reducing potential for vapor carry under to tankage.	9/30/24
	Implement engineering solution identified from first corrective action	TBD
